# Minnesota's Lake Superior Coastal Program

## Flute Reed River Water Quality / Quantity Monitoring and GIS Mapping for Problem Reach Identification

February 19, 2010

Project No. 306-STAR03-10

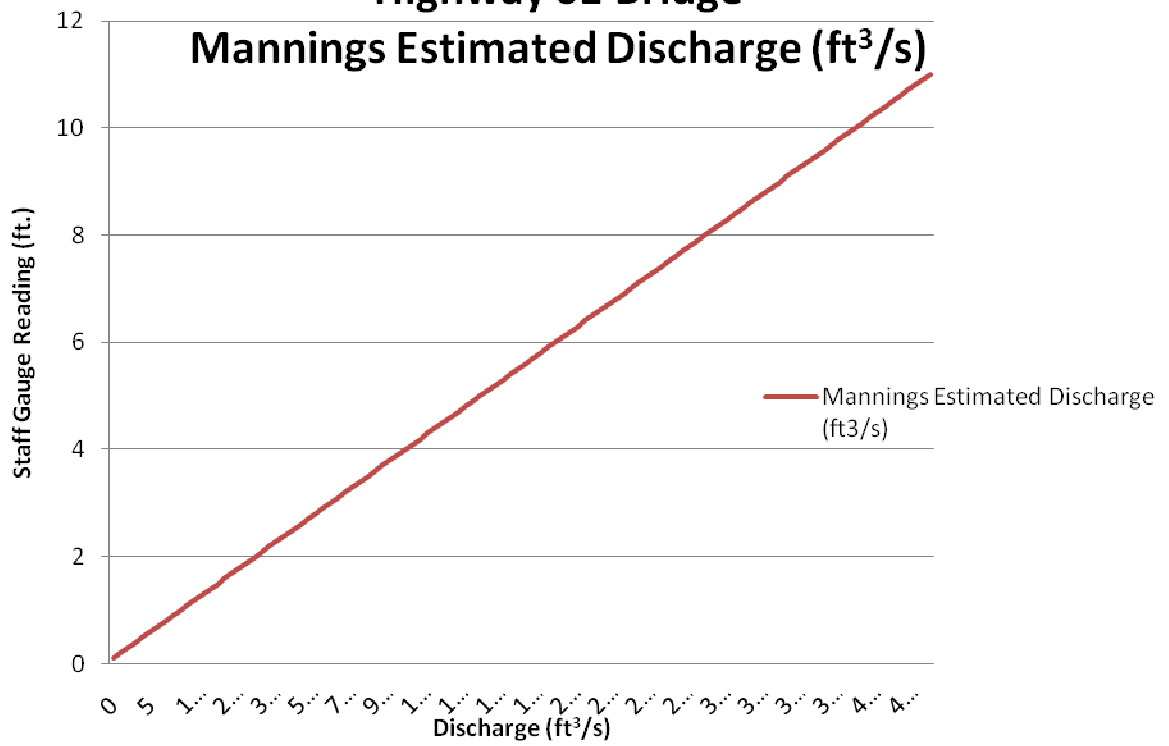
# Flute Reed River Highway 61 Bridge

## Mannings Estimated Discharge (ft<sup>3</sup>/s)

Water quantity data was entered into an excel spreadsheet developed for this project. The spreadsheet applied Manning's Equation for estimating water quantity (discharge). Survey data from MPCA was imported into Autocad to determine cross sectional areas and wetted perimeter inputs for the equation and published roughness coefficients were applied for channel conditions. The output from this operation was a stage vs. discharge relationship. A

copy of this deliverable is included in **Appendix B - Water Quantity Data** and with the CD that accompanies this report. Data from this operation was compared to hydraulic reports produced by MN DOT. To validate and improve this data two options exist. First, manual field discharge measurements, utilizing the survey for cross sectional areas and an in stream velocity meter, could be conducted. The problem with this technique is that measuring high flows in the Flute Reed River would be dangerous or impossible. The better option would be to contract with MPCA and/or the United States Geological Survey (USGS) to utilize a River Cat, which is a mechanical device that is set up to take these measurements and is controlled from shore. Precision from this method would be much better and safer. Ultimately a formal river gauging station would need to be installed for precise measurements of discharge.

-Preliminary Stage Discharge Graph
